PENROSE  
TOURING

## Caravan Damp Report

Caravan. Lunar Ariva SGLS000LU61012030

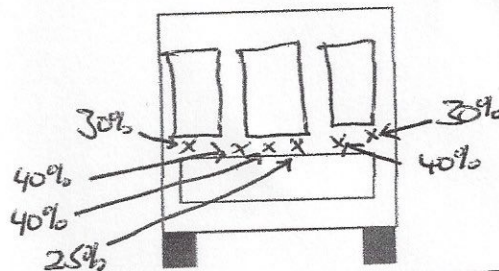
BELOW 16% EXCEPT WHERE SHOWN.

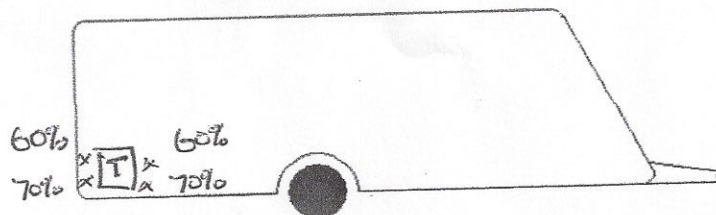
BELOW 16% EXCEPT WHERE SHOWN.

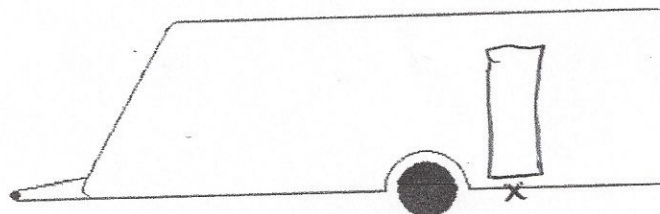
WOOD SOFT UNDER DOOR, ALTHOUGH ALL READINGS BELOW 16% ON THIS SIDE.
